Manhole Inspection Summary

Manhole # S23C1_018MH

Location Address: **2400 Annor Court**

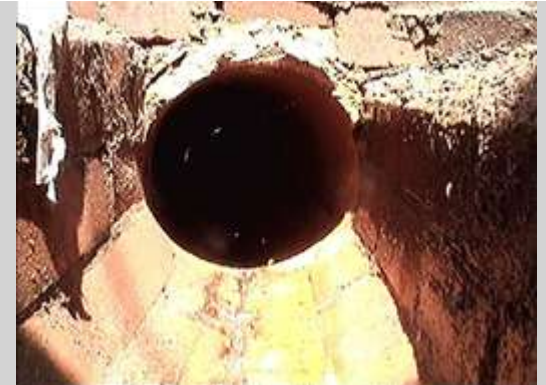
12 O'Clock Outflow

8 in. Circular Gravity Sewer
Pipe Out @ 12 O'Clock

Pipe Height: **8.4** (in.) Rod and Bar (Angled)

Pipe Material: **Clay** ☐ Pipe Lined

Invert Depth: **6.89** (ft.) Flow Characteristics: **Slow**

Deposits: ☒ None ☐ Mud ☐ Sludge ☐ Debris ☐ Grease

Infiltration: **None** Pipe Seal Cond: **Sound**

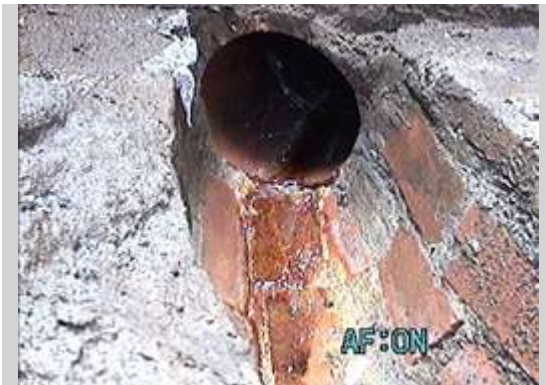
7 O'Clock Inflow

6 in. Circular Gravity Sewer
Pipe In @ 7 O'Clock

Pipe Height: **6** (in.) Rod and Bar (Angled)

Pipe Material: **Clay** ☐ Pipe Lined

Infiltration: **None** Pipe Seal Cond: **Sound**
